Office of Inspector General
United States Department of State

AUD-CGI-20-36

July 2020

**Management Assistance Report:
Execution of the New Embassy Compound
London Construction Project Offers
Multiple Lessons**

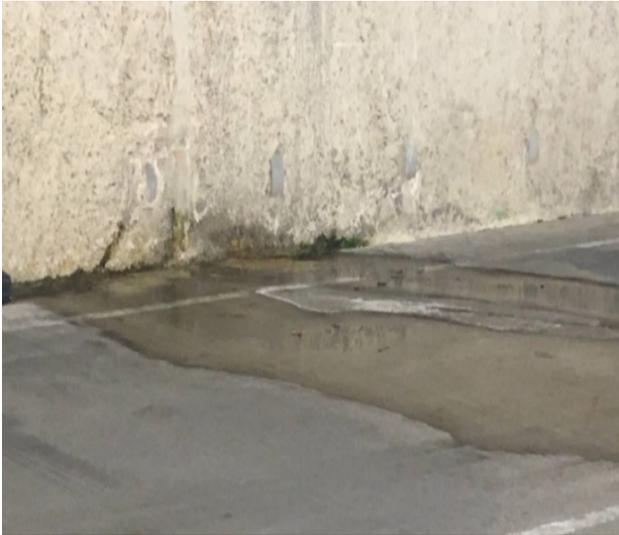
OIG found ground water seeping into the lower level of NEC London because a decision was made, following a value engineering study, not to include an additional floor “slab” and a perimeter masonry wall in the lower level. The purpose of a value engineering study is to improve the function or reduce cost by promoting the substitution of material and methods with less expensive alternatives without sacrificing functionality. According to OBO policy, a value engineering study is required for construction projects that cost more than \$5 million.¹⁷

The value engineering study conducted for NEC London proposed removing the additional floor slab on the lower level to reduce cost. OBO accepted that recommendation and removed the floor slab from the design. However, the value engineering study also noted the potential consequences of removing the slab, stating, “The parking would be directly on the structural slab. It is noted that there will be moisture on the parking slab coming up from below. There will be drainage to move the water away, but moisture will be present.” OBO made the decision to remove the additional floor slab and, as predicted in the value engineering study, ground water is seeping into the lower level of NEC London. Figures 2, 3, and 4 are photographs from the lower level of NEC London taken in January 2020.

Figure 2: Ground water seeping into the lower level parking garage of NEC London.
Source: OIG photograph taken January 2020.

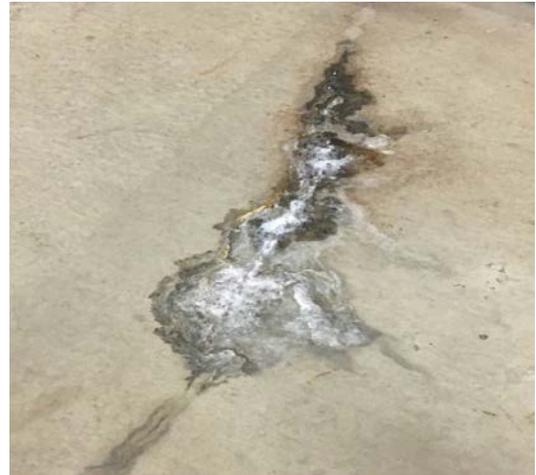
Figure 3: Ground water seeping through the lower level floor of NEC London.
Source: OIG photograph taken January 2020.

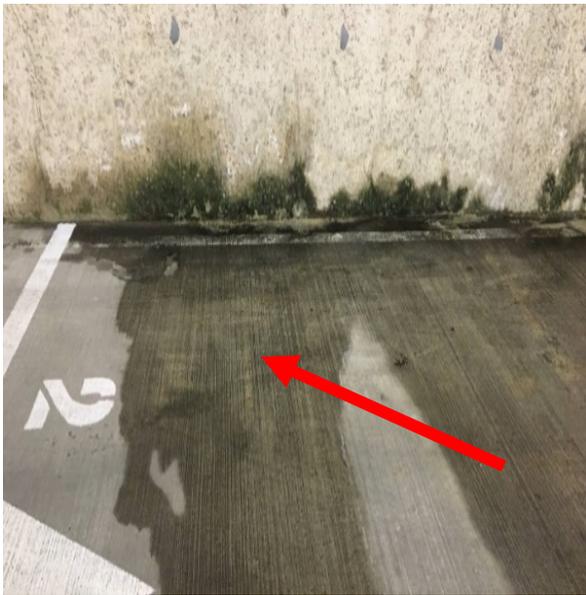
Figure 4: Mold forming on the wall in the lower level parking garage of NEC London.
Source: OIG photograph taken January 2020.

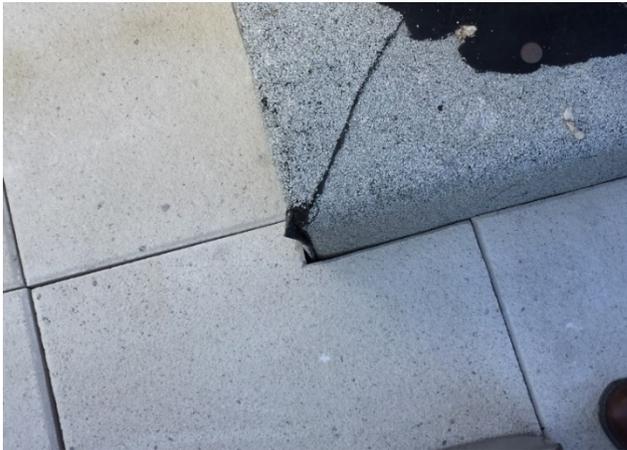
OIG found that portions of the roof at NEC London were improperly installed and will require continuous attention to avoid leaks and water damage. According to the NEC London project director, the roof design for NEC London prepared by the A&E contractor KT never aligned with OBO's expectations. However, OBO did not require changes to the design from the A&E firm. Instead, an OBO roofing expert was assigned to the NEC London project to make changes to the original roof design. This created a "hybrid" design with features from both the A&E

contractor's design and from OBO's standard roof design. OIG found that the finished roof was completed improperly and identified defects with the equipment pads. Because OIG does not know the basis by which OBO chose to alter the design of the roof after accepting the design of the roof from the A&E contractor, OIG is not offering a recommendation to address this condition. Figures 5 and 6 show the results of improper installation of roofing over equipment pads.

Figure 5: Improper installation of roofing over equipment pad.

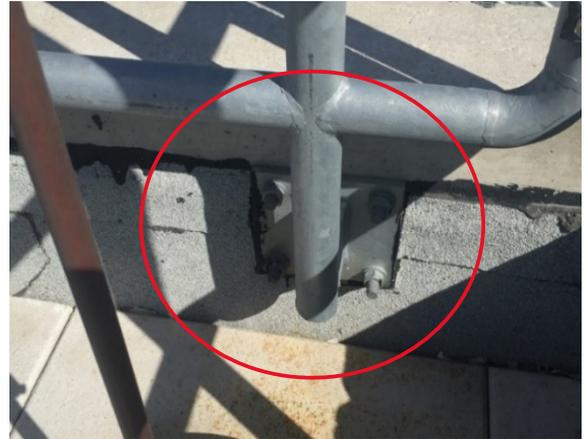
Figure 6: Improper installation of roofing on sidewall.

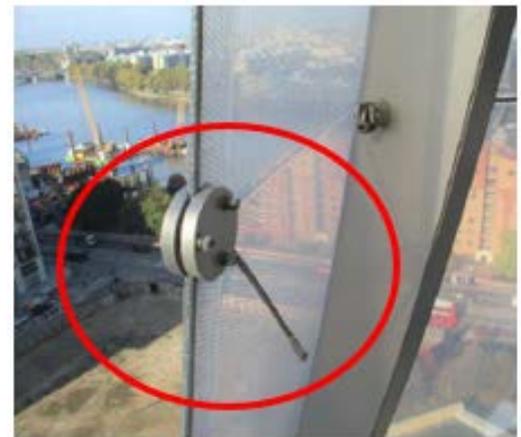
In addition, the contractor inspecting the tensioned sails listed in its inspection report 30 types of construction phase defects and hundreds of individual deficiencies, including wrinkles, splits, and tears in the sails and several loose wind cables. Additionally, the inspectors found missing, improperly installed, or incorrectly sized nuts, bolts, and clamps used to secure the sail panels, which caused broken or missing fittings. The audit team observed detached brackets and other defects during the team's visit, but for security reasons could not take photographs.

Figure 7: Wind Cable detached from building.

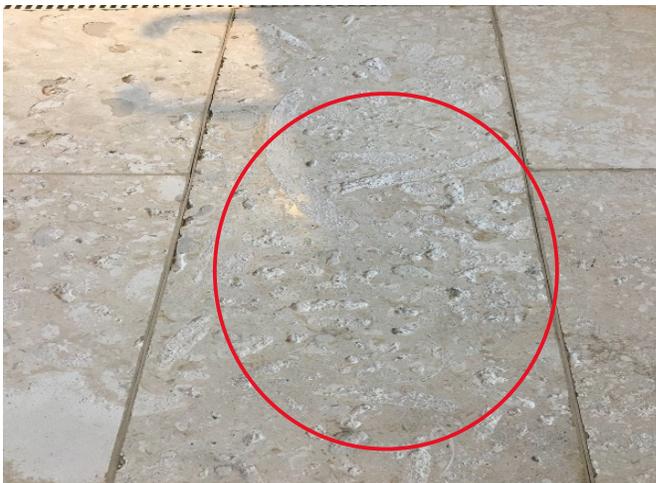
OIG found that interior stone tiles have cracked and exterior stone pavers have deteriorated to the point that vehicle traffic leading into the main entrance of NEC London has been limited to avoid additional damage. OIG could not determine the specific cause for the defects, but the quality of the tiles and stone pavers as well as the way they were installed could be the reason since NEC London has only been open for approximately 2 years. Figures 8, 9, and 10 demonstrate these defects, including cracking, delamination, and color variances.

Figure 8: Damaged interior stone tiles on sixth floor showing spalling and delamination.

Recommendation 5: OIG recommends that the Bureau of Overseas Buildings Operations, in coordination with Embassy London and prior to issuing the Certificate of Final Acceptance, verify that the stone pavers and tiles that were installed at Embassy London were the grade and quality of materials approved and that they were installed correctly. If the grade and quality of materials is not consistent with contract requirements, in coordination with the Bureau of Administration and the Office of the Legal Advisor, OBO should determine the extent to which the construction contractor, B.L. Harbert International, LLC, (under contract # SAQMMA-12-C-0111) is responsible and recover any associated costs.

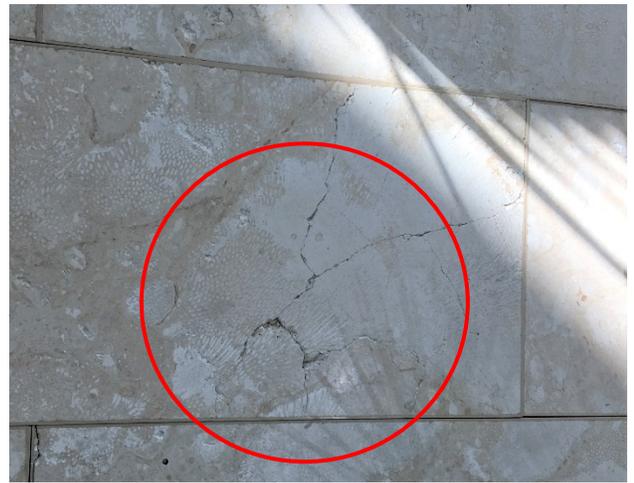
Figure 9: Damaged (cracked) interior stone tiles.

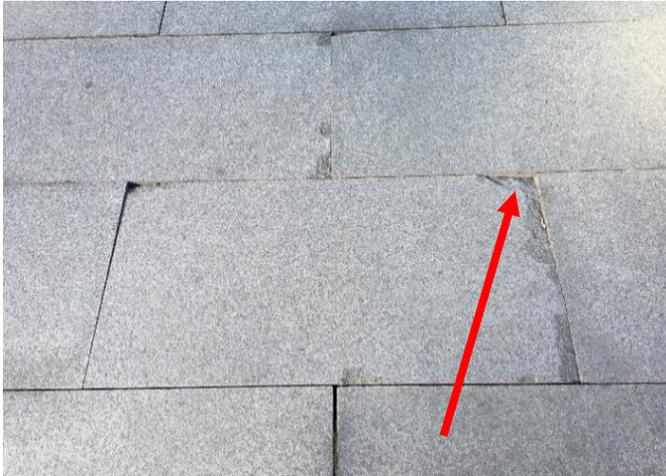
Figure 10: Damaged edges of exterior stone pavers on embassy driveway.
