Office of Inspector General

AUD-MERO-17-50

**Management Assistance Report:
Additional Measures Needed
at Embassy Amman to Safeguard
Against Residential Fuel Loss**

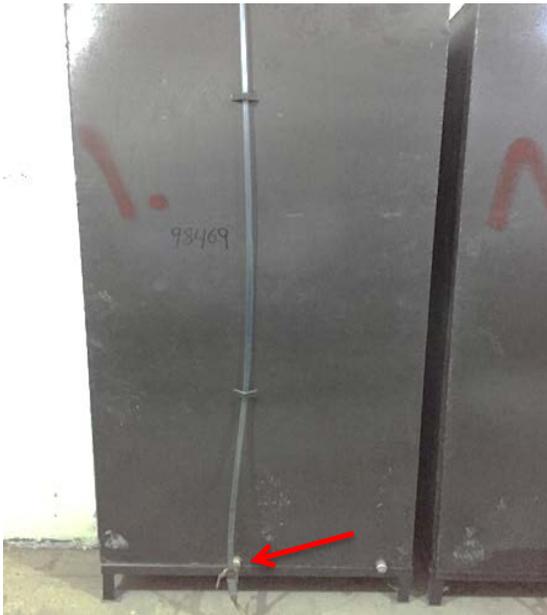
Figure 1: Standard fuel tank with valve and hose to transfer fuel to the boiler, which is positioned in a separate room.

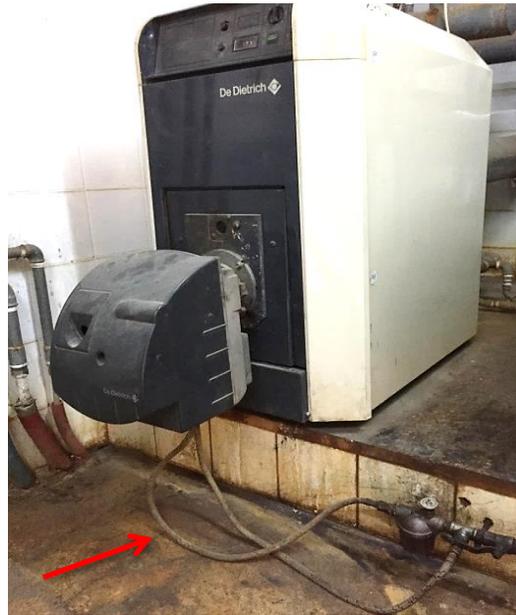
Figure 2: Standard boiler with a fuel hose to receive diesel fuel from the fuel tank to operate the boiler engine.

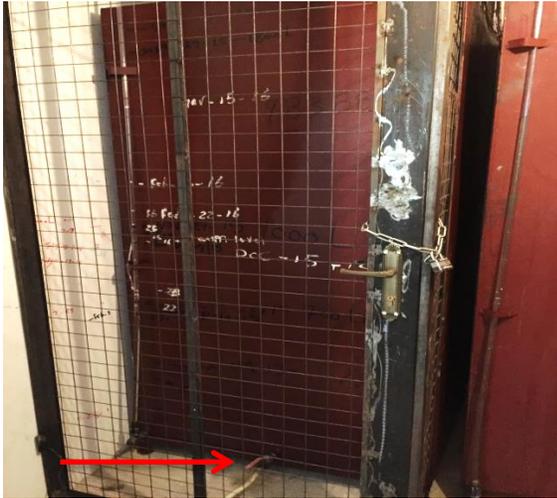
OIG assessed 20 fuel tanks and 14 boilers¹⁸ at 12 residential buildings. Of the 20 fuel tanks assessed, 1 tank had a wire cage (see Figure 3), 14 of the tanks had plated cages covering the front of the tank (see Figure 4), and 5 tanks were unprotected. Of the 14 boilers assessed, 8 were protected with cages, while 6 were unprotected.

Figure 3: Fuel tank surrounded by a wire cage with the fuel line extending from the bottom of the tank into the floor to connect to the boiler in the next room.

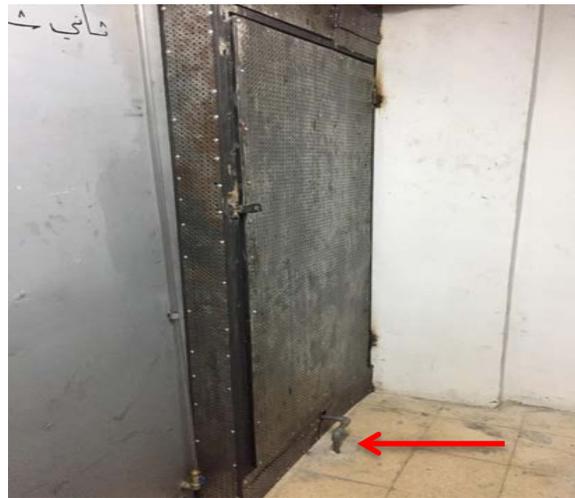
Figure 4: Fuel tank surrounded by a plated cage with the fuel line extending from the bottom of the cage into the floor to connect to the boiler in the next room.

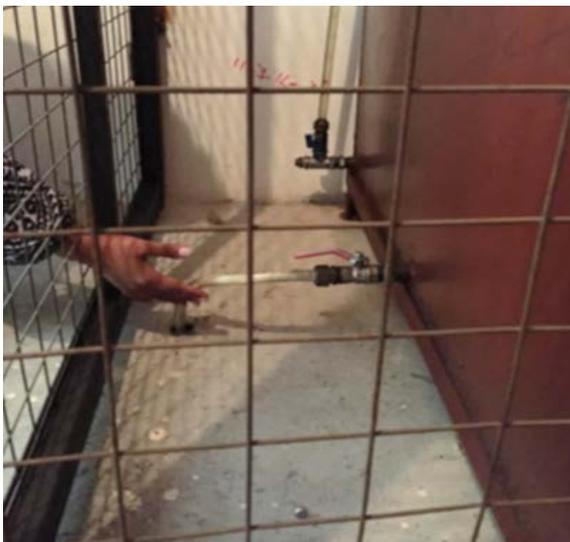
During OIG's March 2017 site visit to Embassy Amman, OIG circumvented each of the established safeguards. For instance, at the residence with the wire cage, OIG determined that the wire cage would not prohibit someone from easily slipping his hand through the cage to disconnect the fuel tank's dispensing line and drain fuel (see Figure 5). In addition, the lid on the diesel fuel tank did not fully cover the tank, leaving a 2-inch gap to allow someone to drop a hose into the tank and siphon diesel fuel (see Figure 6). OIG also found a water bottle partially filled with diesel fuel that appeared to have been drained from one of the boiler's fuel lines (see Figure 7).

Figure 5: Wire cages with gaps big enough for hands or tools to fit through.

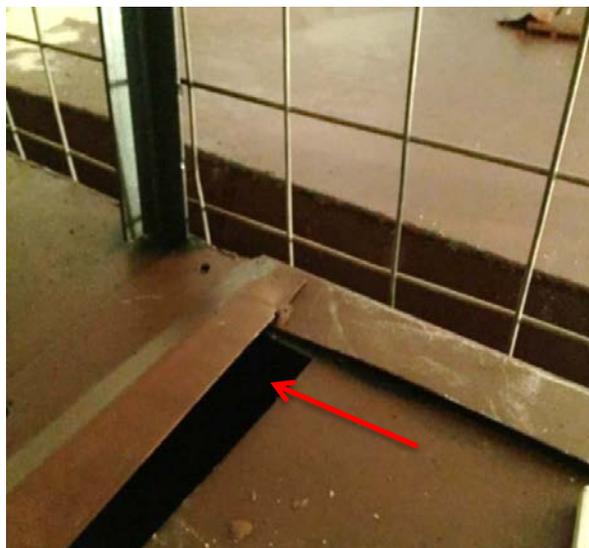
Figure 6: Gap in the top of fuel tank large enough to slip in a hose and siphon fuel.

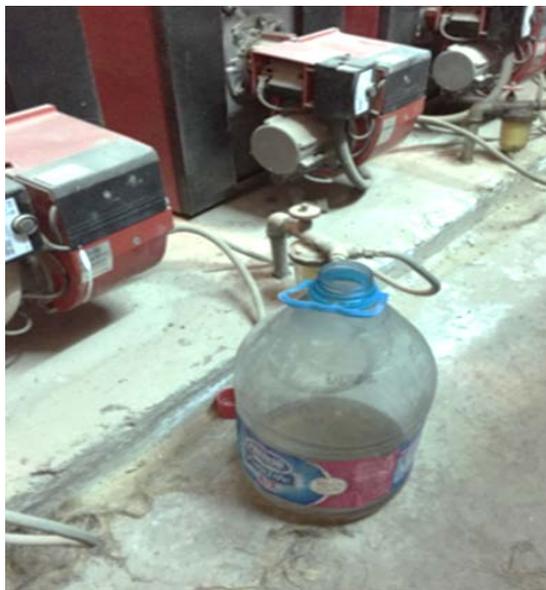
Figure 7: Water bottle with fuel found in boiler room.

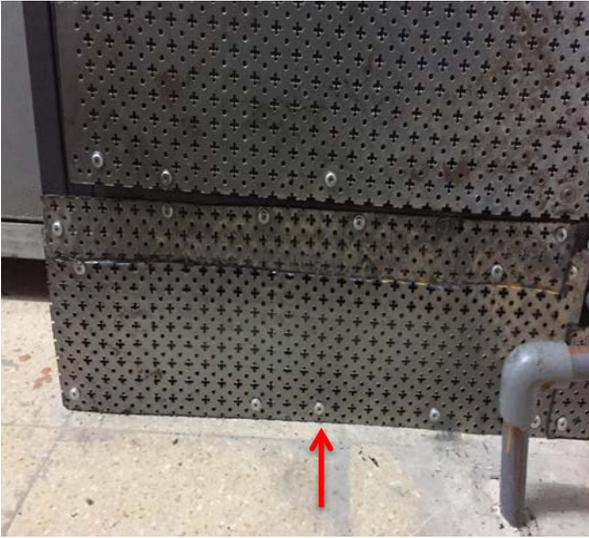
Plated cages also did not provide adequate defense against fuel loss. Although the plated cages would stop someone from placing their hands or tools through the cage, at least two of the plated cages had their panels screwed to the outside of the frame, which exposed the screws so that anyone with a screwdriver could easily remove the plates and access diesel fuel (Figure 8). One of the 14 plated cages contained the screws on the inside of the frame, prohibiting anyone from removing the plates to access fuel; however, in this instance, the plated cage could still be easily circumvented because an arm could be slipped between the plated cage and fuel tank to access the fuel valve and hose (see Figure 9).

Figure 8: Plated cage screwed to the outside of the frame for easy access.

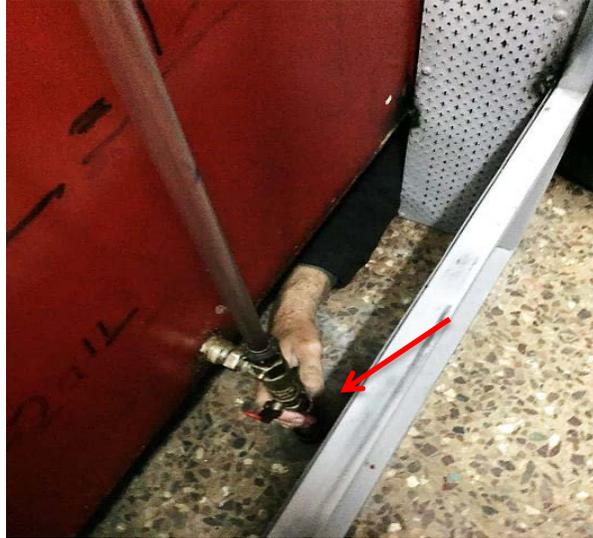
Figure 9: Plated cage with screws on the inside could still be easily circumvented.

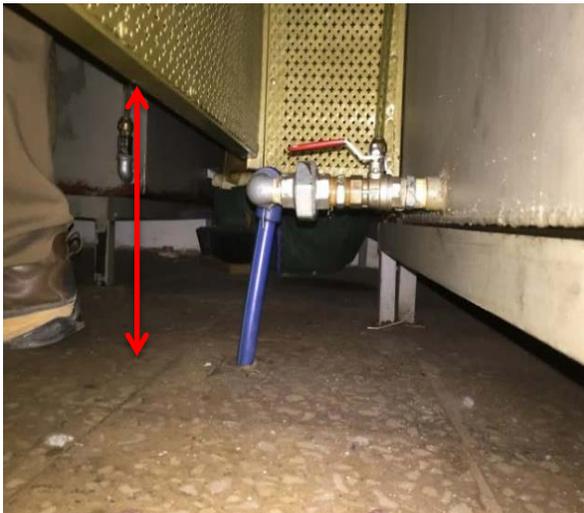
In addition, cages designed to prevent unauthorized access to the fuel tanks left gaps that continue to allow access to the fuel lines. OIG observed two plated cages that did not extend to the floor: one stopping approximately 12 inches from the floor, thereby allowing direct access to the fuel dispensing line at the bottom of the tank from which fuel could be drained (see Figure 10). Furthermore, at least one of the plated cages did not extend to the wall, also allowing access to the tank (see Figure 11).

Figure 10: Plated cage does not extend to the floor allowing access to the fuel line.

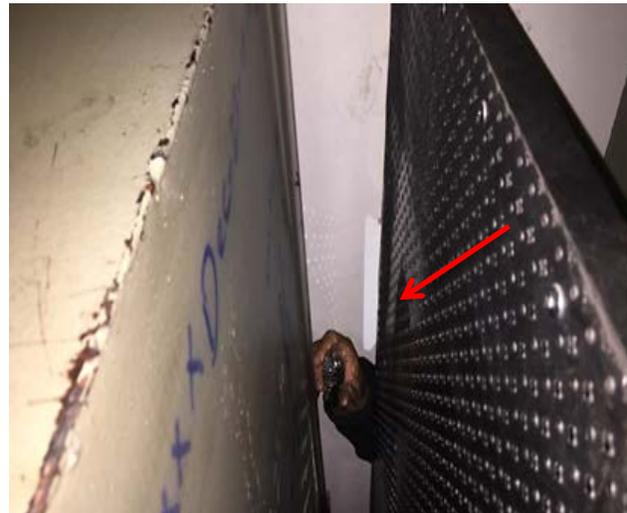
Figure 11: Plated cage does not extend to the wall allowing access to the fuel tank.

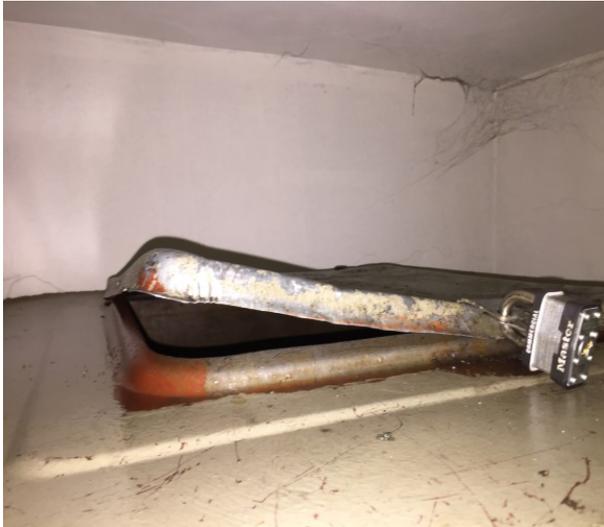
Finally, with or without cages, OIG observed additional vulnerabilities in fuel tank and boiler rooms that could leave embassy residences susceptible to diesel fuel loss. For example, OIG observed that the plate on top of a fuel tank could be removed or bent open, and a hose

dropped into the tank to siphon fuel (see Figure 12). Similarly, in the boiler room, diesel fuel could be drawn by running the boiler to extract fuel from the tank and detaching or splitting the hose to steal fuel (see Figure 13).

Figure 12: A bent lid on the top of a fuel tank could provide easy access to siphon fuel.

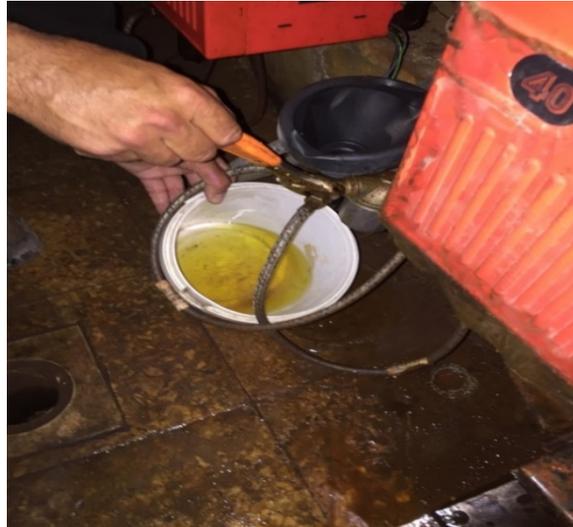
Figure 13: Fuel could be drained directly from the boiler's fuel line to another container using a splitter valve.
